APOLLO 12

LUNAR SURFACE MAGNETOMETER ANOMALIES

INVESTIGATION OF FAILURE OF ALL SENSOR CHANNELS

SSM-13-1399

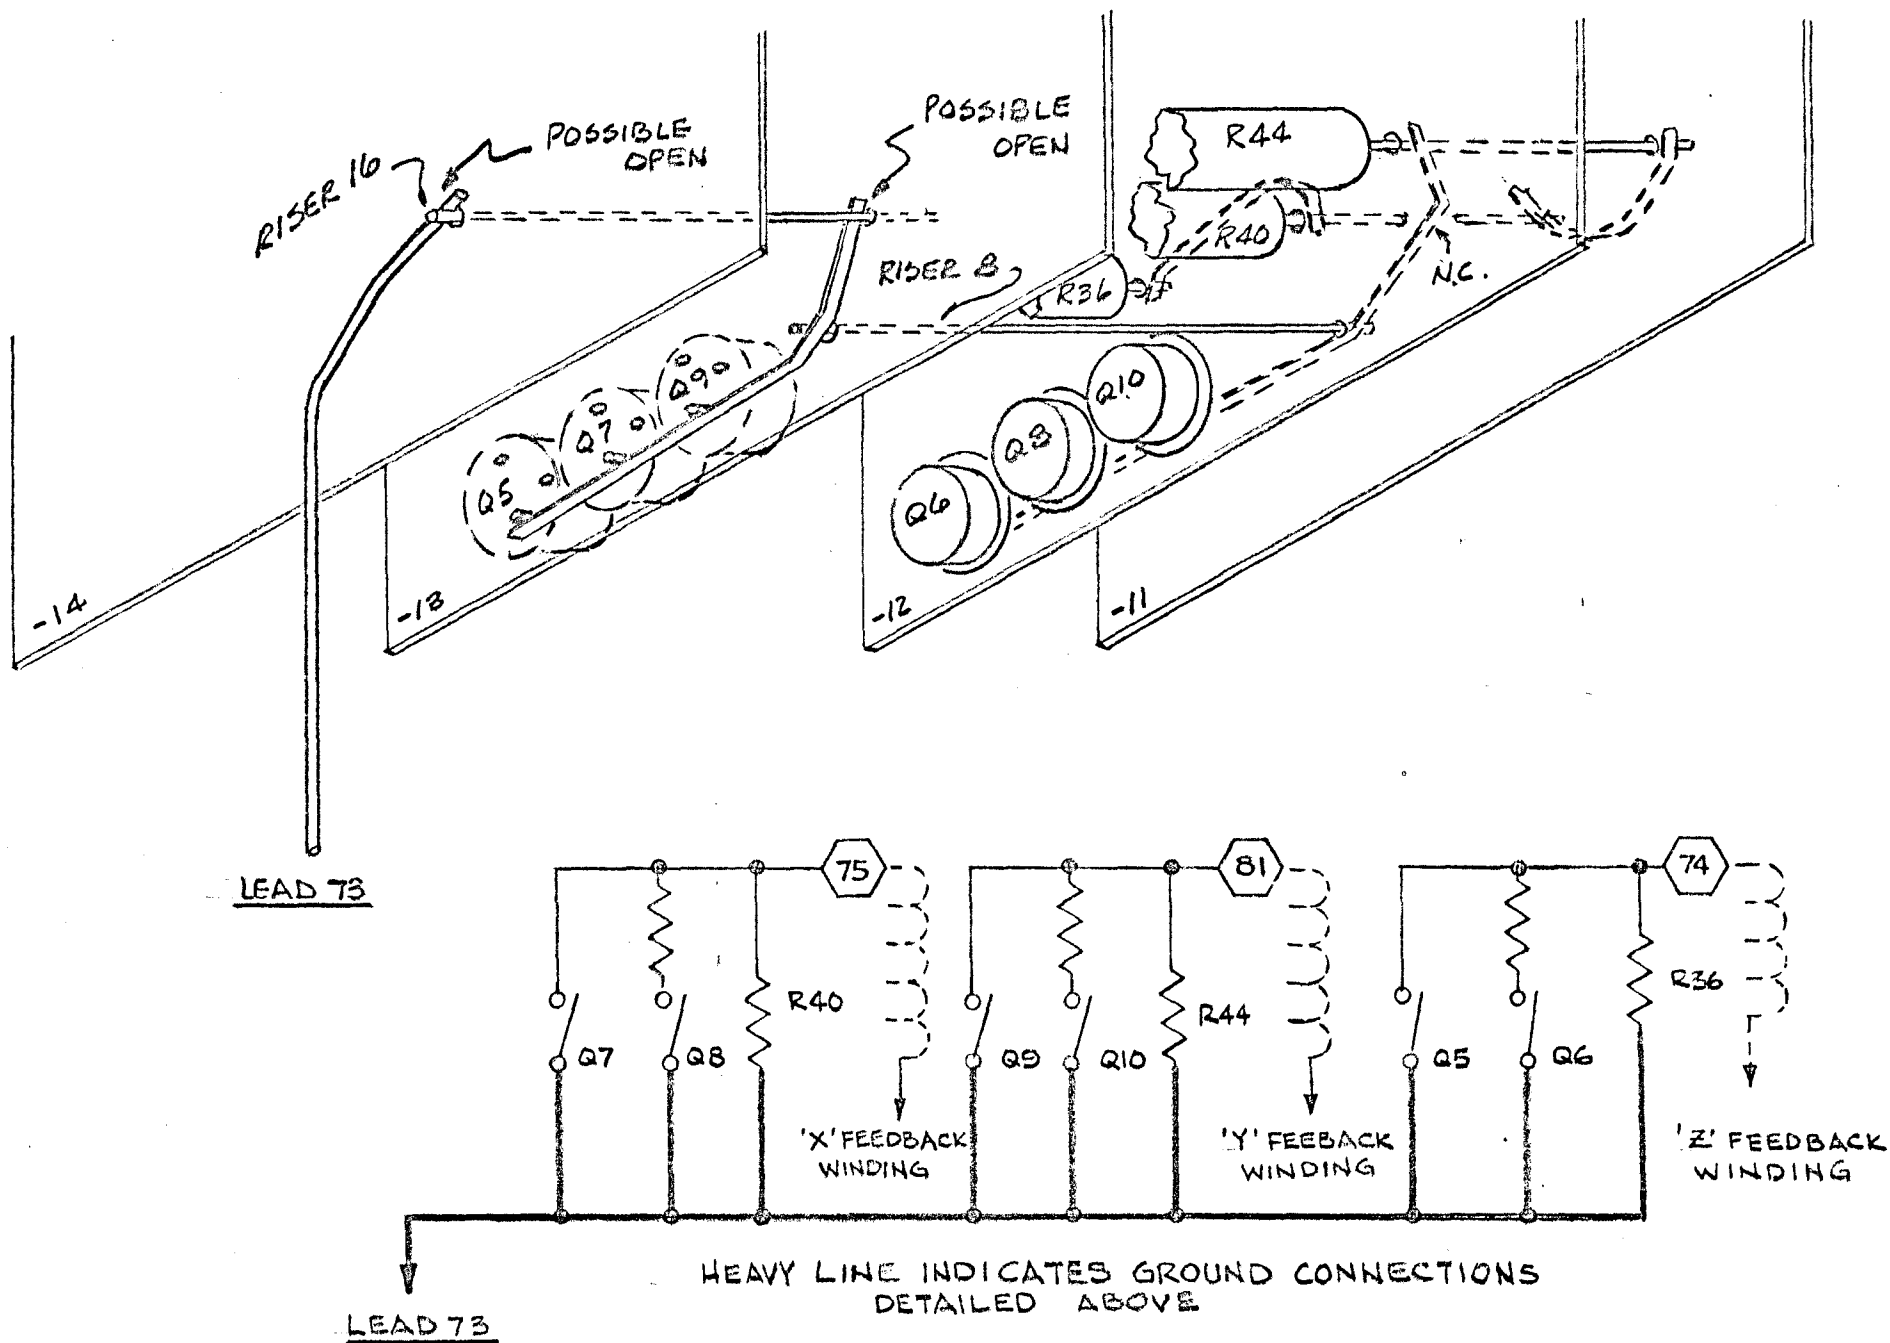
The simultaneity of the anomalous behavior in all three channels, the nature of the anomalous behavior in the channels and the results of the tests conducted by command of the instrument indicated that the anomaly was due to a failure in the circuitry which was common to all three channels in the sensor electronics. The only point common to all three channels in the sensor electronics is in the Cal/Offset Bias Generator - Summing Network Module. Figures 1, 2 and 3 depict the pertinent parts of the sensor channel electronics used to isolate the failure. An open in the feedback channel will typically drive the channel to full scale saturation. The direction of the drive to saturation being dependent on

Fig 2 LSM 6 ANOMALY ANALYSIS - DETAIL OF CAL/OFFSET BIAS GEN GROUND

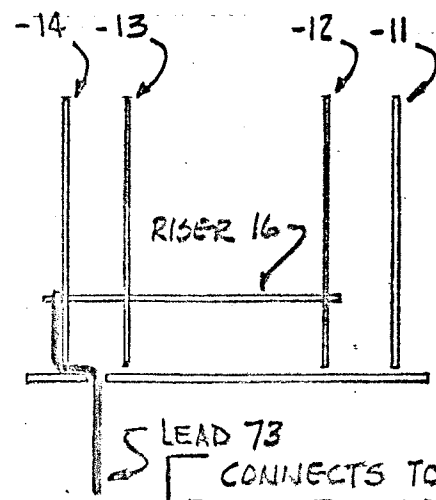
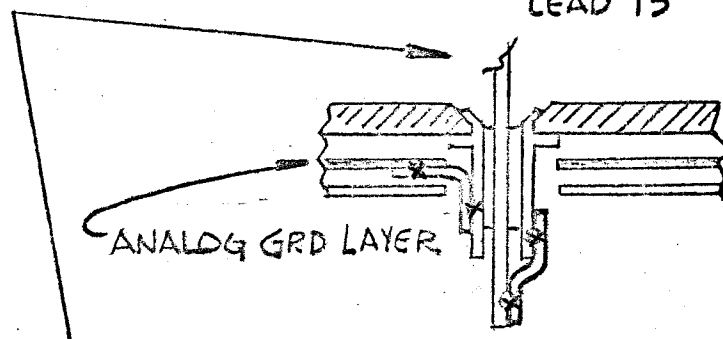
(e)

* = WELD CONNECTION AND POSSIBLE OPEN

ASSEMBLY DETAIL OF SUMMING NETWORK CORDWOOD MODULE (PART OF CAL/OFFSET BIAS GEN) FIGURE 3

Analysis of the most probable cause of the failure indicates that the open occurred at one of the four welds on the motherboard indicated by x's in Figure 3e and was due to thermal stressing. Experience on the Pioneer Magnetometer and on the LSM program indicates that the preponderance of opens associated with cordwood modules occur at the motherboard connections rather than internal to the potted modules. It is concluded that an open circuit at pin 73 on the A1 motherboard is the most likely cause of failure.

A recently adopted procedure for more intense inspection and rejection criteria for motherboard connections is described under 3.4.2. The procedures are effective. Applied to LSM #7, no failures due to opens at the motherboard connections occurred during instrument checkout following assembly, pre-acceptance test and acceptance test.

The past history of motherboard pin failures associated with extreme temperature environments and the circumstances of the failure in this instance strongly indicates that temperature stressing caused an ultimate rupture of a marginal pin/tab weld connection. Corrective measures described under 2.3, 3.4.3 and 3.5.4 will mitigate such thermal stresses. Additional instrument temperature tests to levels in excess of those anticipated on the lunar surface are now conducted as noted in Paragraph 3.5.3.
